96-CMC-R0290

SHOCK TESTING OF A DRY CHEMICAL
FIRE EXTINGUISHER inclusive a BRACKET

TNO Building and
Construction Research

Date July 1996

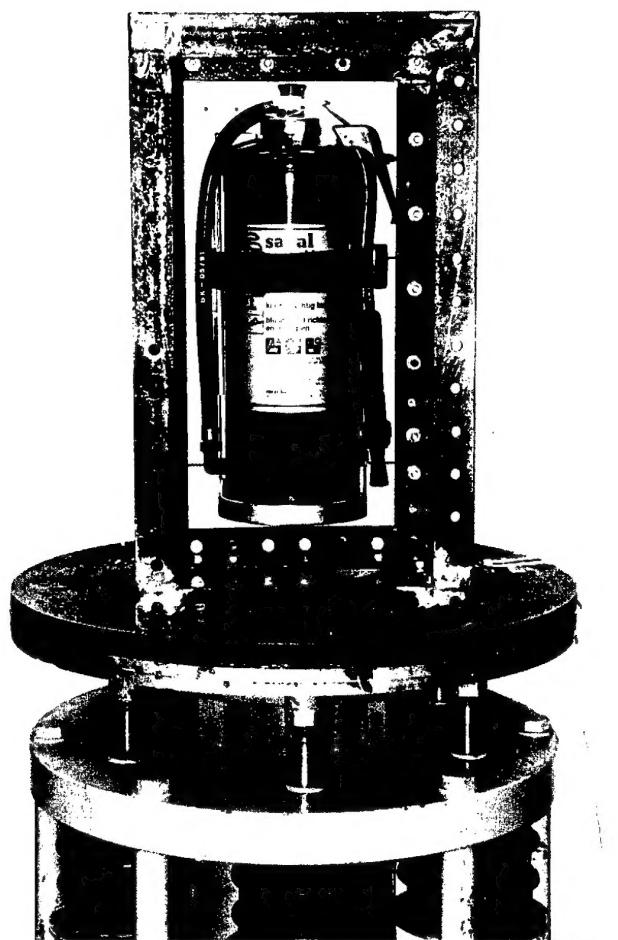
Figure 1, Fire extinguisher on test in the vertical direction (Z).

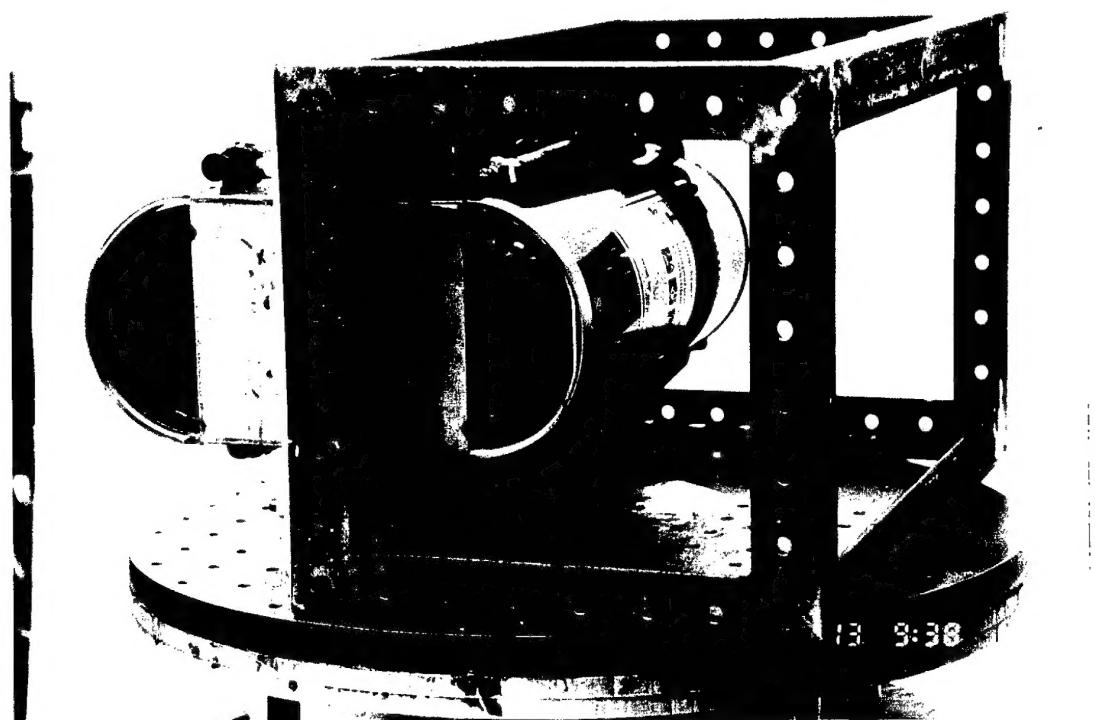
Figure 2, Fire extinguishers on test in the transverse direction (+ and -).

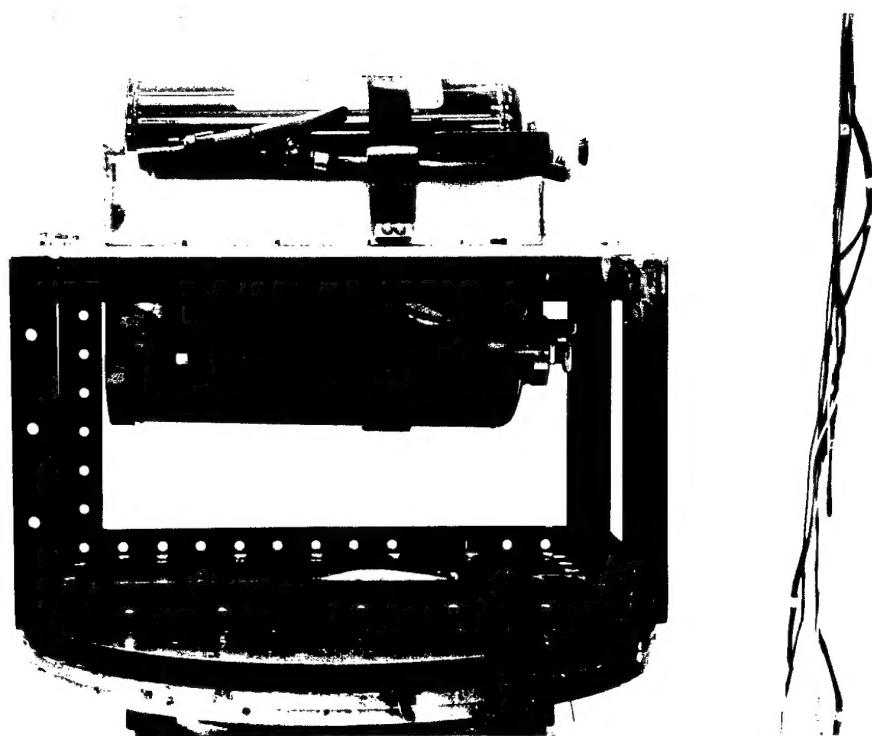
Figure 3, Fire extinguishers on test in the perpendicular direction (+ and -).

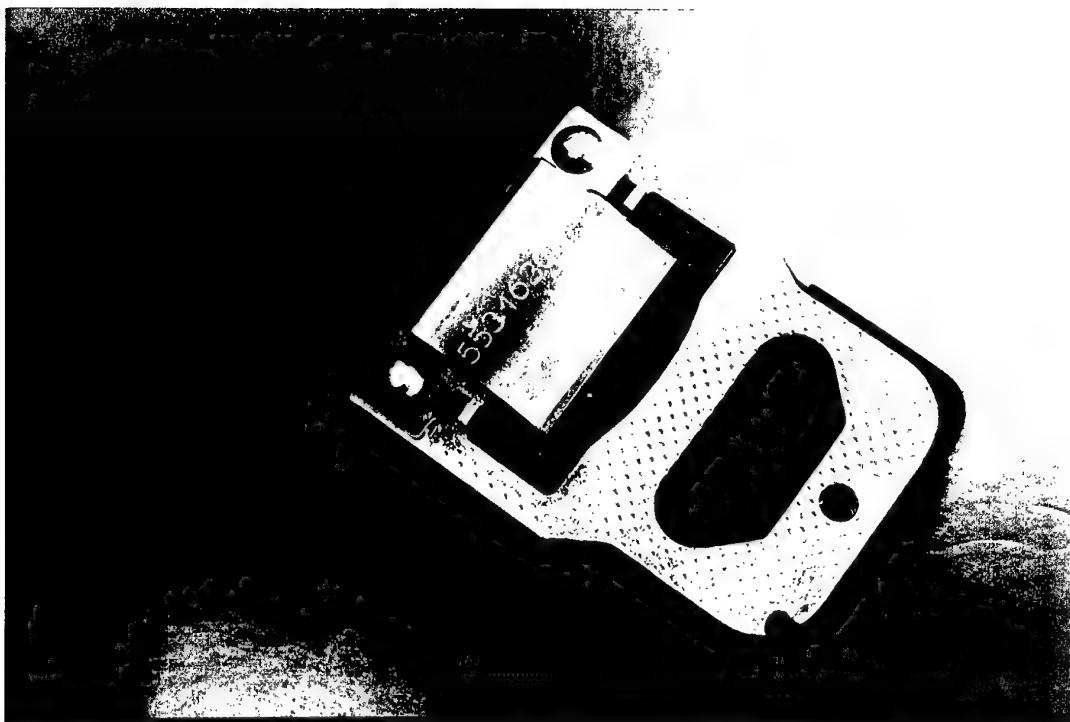
De vergrendeling van de snelsluiting van de ophangbeugel functioneerde in één beproevingrichting niet voldoende, waardoor de poederblusser uit de ophangbeugel werd gelanceerd.

During the test in progress the safety belt snap lock failed.

Figure 8, Original snap lock of the safety belt, (note: the cover has been removed).

Before the next shock tests a modification was carried out in the snap lock device.

06	transverse (X)	An additional piece of rubber was placed between the steel spring and the lock cover to increase the stiffness (figure 9). The previous test was repeated with the modified lock (-X) and the original lock (+X). Both safety belt locks were in good order. Satisfactory result.
07	transverse (X)	For optimization the size of the rubber piece was reduced (figure 10). The shock test was repeated, showing no failures in the locks. Quite some deformation was observed with the bracket base after the four tests in the X-direction, (see figure 11). Satisfactory result.
08	perpendicular (Y)	Satisfactory result.

Figure 9, A piece of rubber has been placed on the spring, filling up the gap between the spring and the cover.

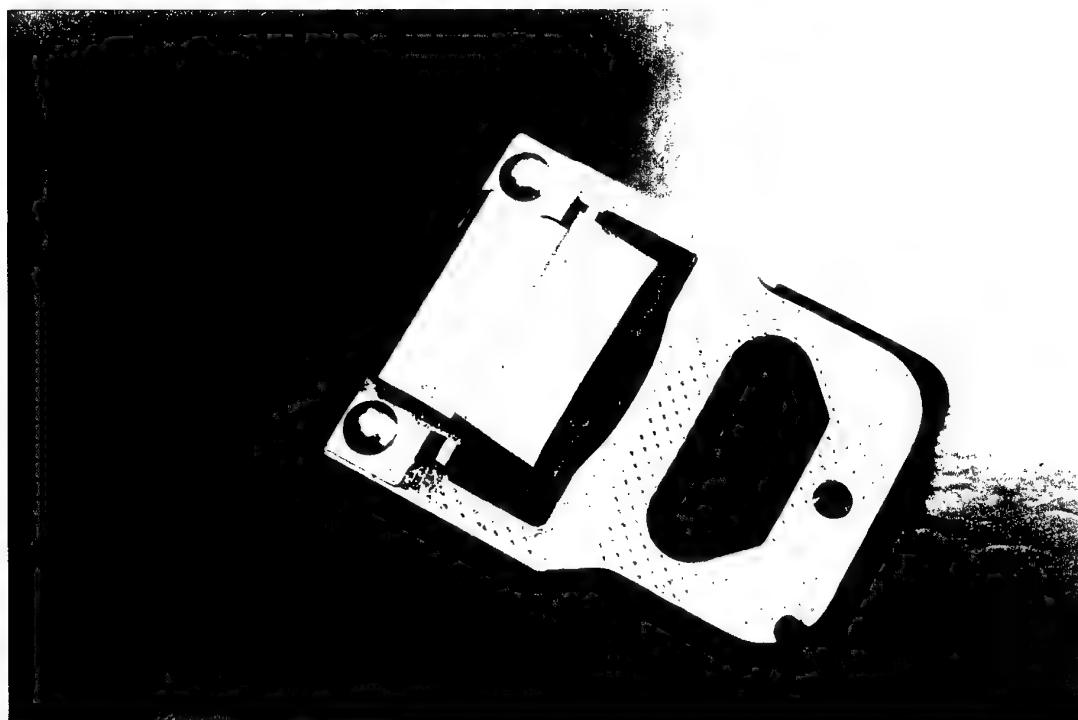
Figure 10, A smaller piece of rubber has been placed on the spring, filling up the gap between the spring and the cover.

Figure 11, Deformed bracket base support.
